WETLAND COMPENSATORY MITIGATION BANK PROSPECTUS BIG HOLLOW WETLAND BANK

Town of Spring Green, Sauk County, Wisconsin

WETLAND COMPENSATORY MITIGATION BANK PROSPECTUS
BIG HOLLOW WETLAND BANK
FEBRUARY 18, 2016

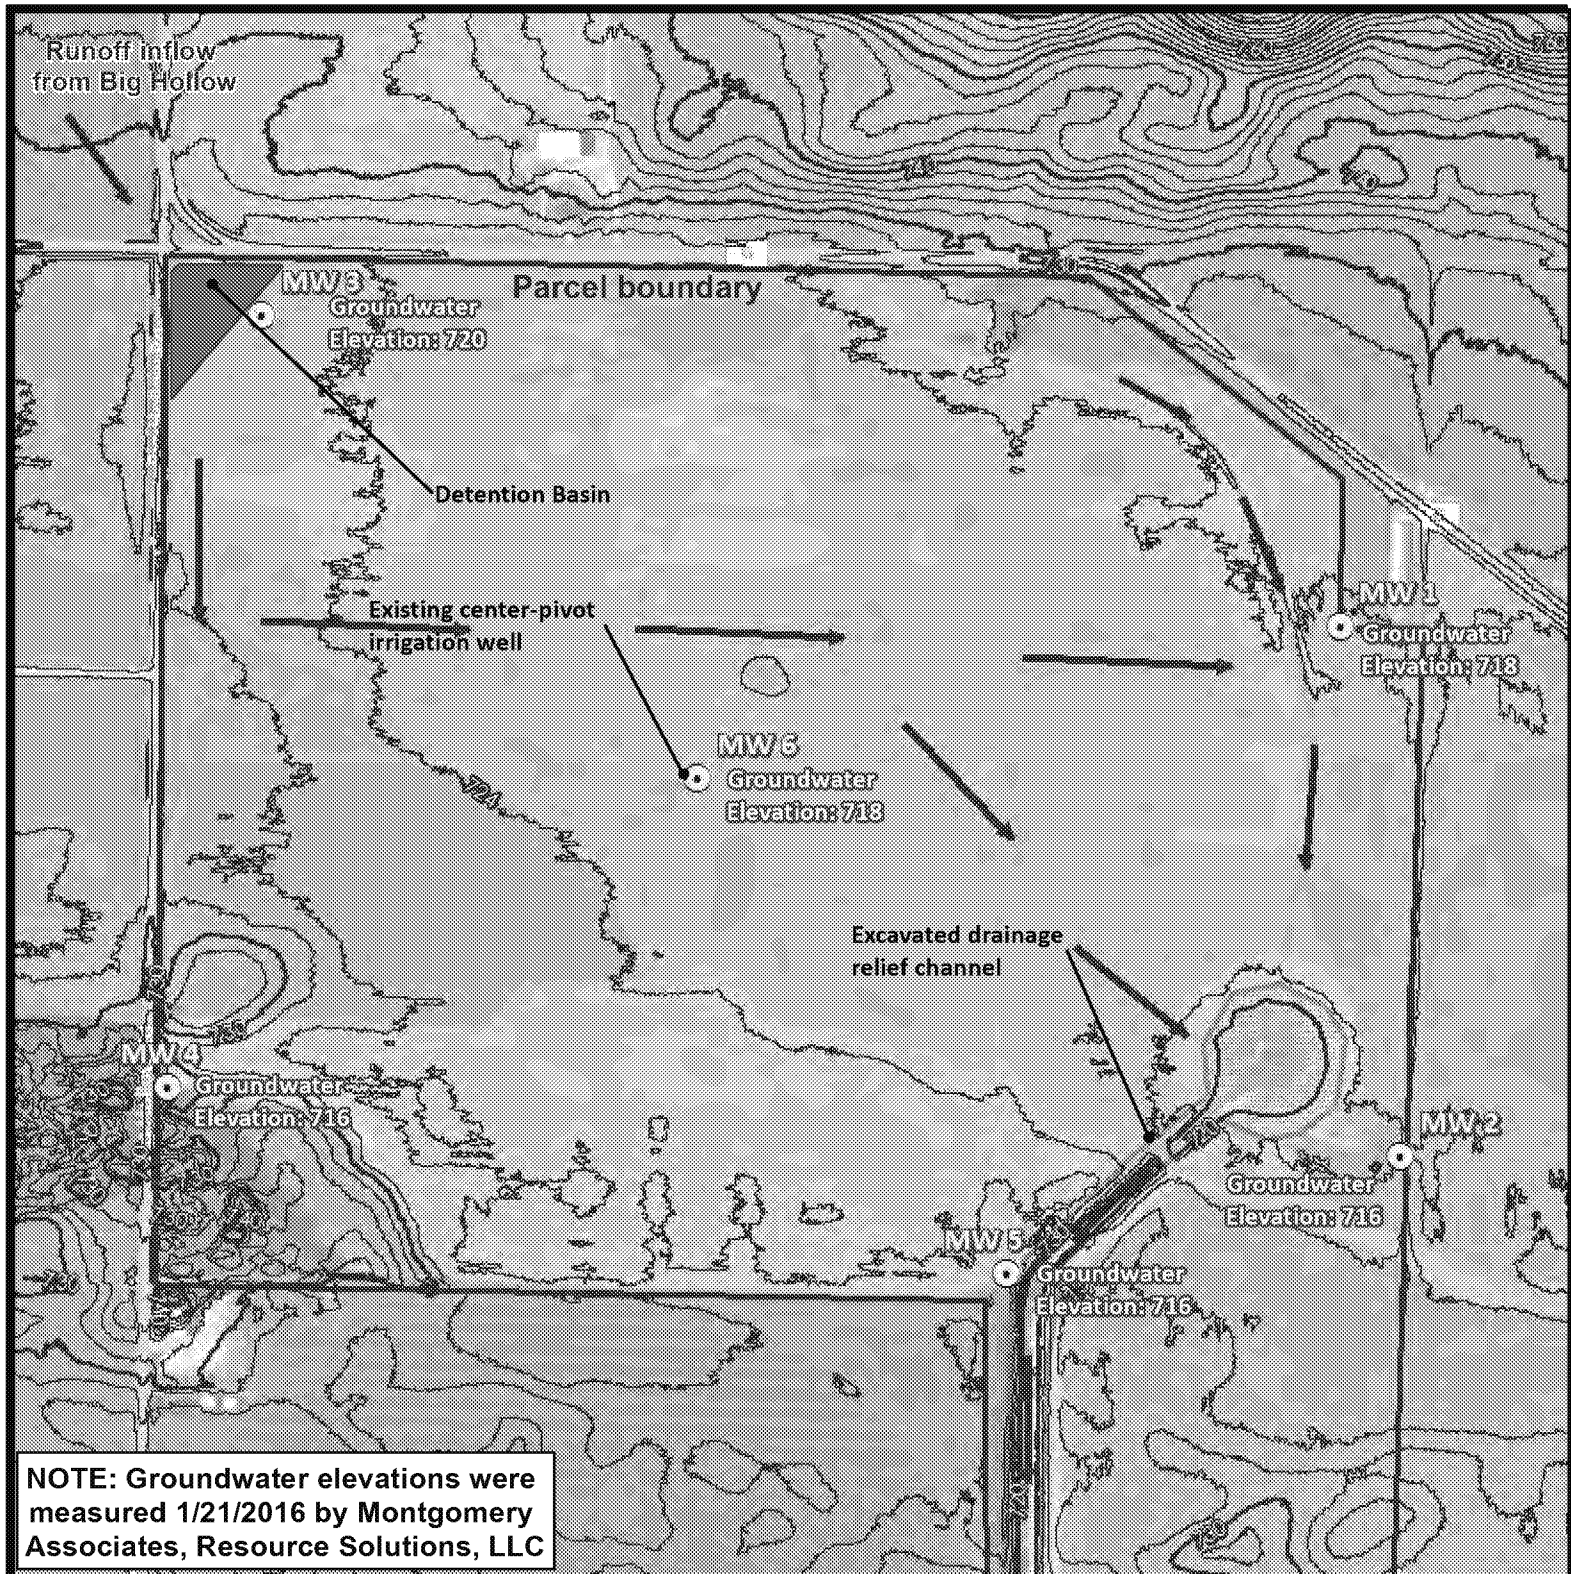
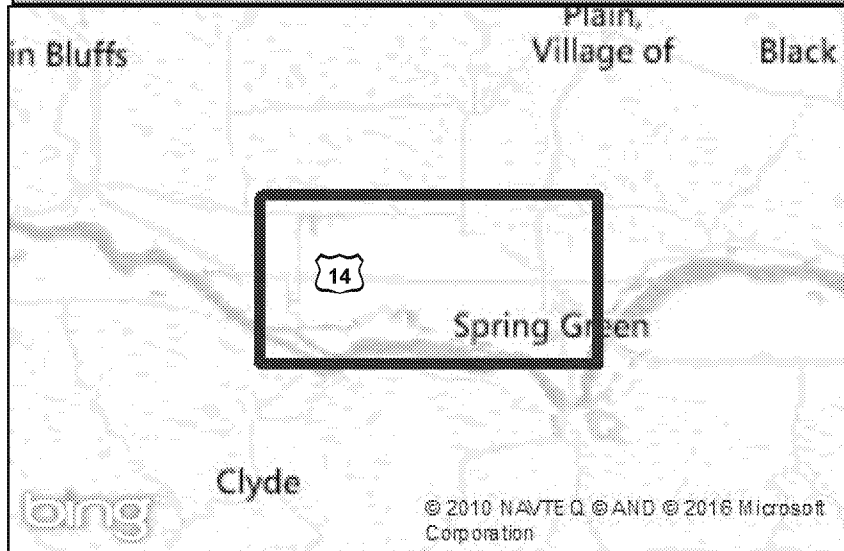
| SHEET NO. Figure 7 | |

NOTES:
1. 2008 Monitoring Wells were installed October 2008. Groundwater levels were measured by the Town of Spring Green on 12/15/2015.
2. 2015 Monitoring Wells were installed December 2015. Groundwater levels were measured by Montgomery Associates Resource Solutions, LLC on 1/21/2016.

**REGIONAL HYDROLOGIC
CONDITIONS MAP**

The site receives substantial surface water runoff inflow from a drainage swale system that conveys runoff to the northwest corner of the site (Attachment 1 - Figure 6. Site Hydrologic Conditions). This drainage originates from local agricultural lands to the north and west and also includes runoff from Big Hollow, a valley that extends into the uplands north of the Wisconsin River valley terraces. The tributary watershed that discharges runoff to the northwest corner of the site has an area of approximately 12 sq.mi. Runoff enters the detention basin at the northwest corner of the site, and from there discharges through the excavated swale eastward and then south, exiting the site in the southeast corner (Figure 6). Before construction of the regional drainage relief channel, surface water runoff entering the site was trapped by the low sand dunes to the south, which created an intermittent condition of ponded surface water and extreme high groundwater conditions that occasionally produced area-wide flooding. The most significant recent flooding episode occurred during the severe storms of 2008, which inundated the site as well as extensive areas to the east and the west, including the Village of Spring Green. In response to the 2008 flooding, an excavated drainage relief channel was built that accepts runoff at the southeast corner of the property and discharges it to the Wisconsin River (Attachment 1 - Figure 7. Regional Hydrologic Conditions). Under present conditions, spring and summer storm runoff typically fills the detention basin and overflow runoff frequently crosses the site from west to east and exits via the drainage relief channel to the Wisconsin River. Areas of local surface ponding and soil moisture accumulation occur throughout the property, especially in the northern portion of the site, corresponding roughly to the extent of the Watseka loamy sand map unit.

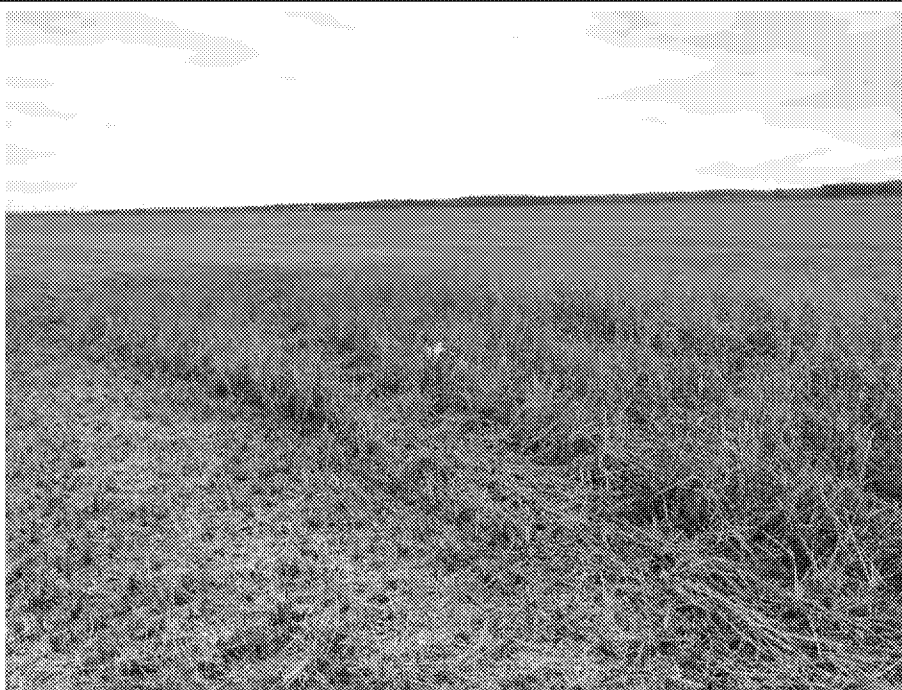
Photo 6. View towards sample point P-5 within wetland W-1; view facing southeast

Wetland 1 (W-1) is a farmed wetland located within a depression dominated by annual weed species within an active agricultural field. The wetland appeared to be contained on-site with no direct inlets or outlets to surface water bodies observed.
